COMMONWEALTH OF PENNSYLVANIA DEPARTMENT OF ENVIRONMENTAL PROTECTION OFFICE OF OIL AND GAS MANAGEMENT

SURFACE ACTIVITIES INSPECTION REPORT

DEP Office	California Oil & Gas Office	Inspection Type	PF
Address	25 Technology Drive, California Technology Park	Permit or Reg. #	051 - 24652
Addr Cont	Coal Center, PA 15423	ESCGP#	
Oper. Name	CHEVRON APPALACHIA LLC	Site #	790607
Oper. Address	700 CHERRINGTON PKWY, CORAOPOLIS, PA, 15108-4315	Project #	
Resp. Official Name	BA Lambie	Farm Name & Well #	YODER 1H
Resp. Official Phone		Other Info	
Latitude	39.97569	Longitude	-79.92387
County	Fayette	Municipality	Luzerne Township
Inspection Code	RTNC - Routine/Complete Inspection	Facility	
Permits / Auth	Well Permit	Site Phase	Drill/Alt
Well Info	Unconventional	Well Kind & Description

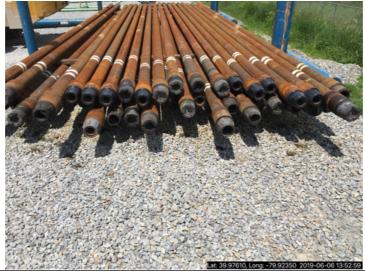
Image_1559848870161

Photo # 3. An equipment rack found without containment, note multiple small stains under rack.
